**Flood Control Project Maintenance**  
**2019 Structure Summary Report**  
**Overall Unit and Item Ratings**

## Butte County Department of Public Works

### Big Chico Creek Diversion Structure

**Flood Control Project Maintenance**  
**Unit Cover Sheet**  
**2019 Structure Inspection Results**

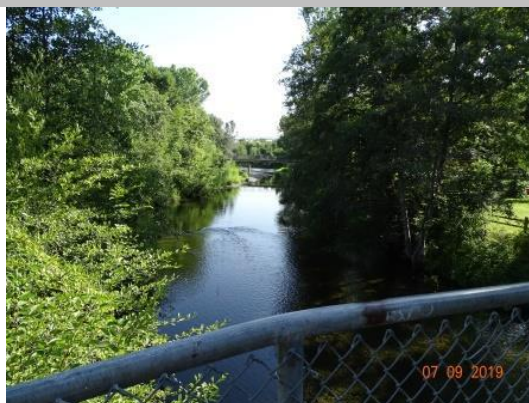
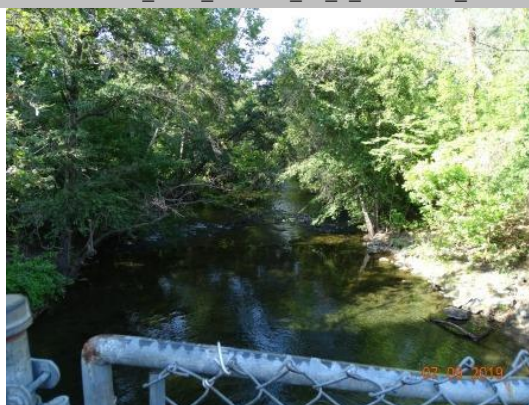
LM Start	0.00	Rating **	A	Issue No.	2
LM End	0.00	Issue Type +	Ma	Location *	
Category	Structures & Concrete Lined Channels	GPS Latitude/Longitude			
		Start		End	
Item	Vegetation & Obstructions	39.761844 °		39.761844 °	
		-121.792559 °		-121.792559 °	
DWR ID	DWR_NA0003_35_t_2012_2				
Action/Comments					
Inspector Comments: Minimal vegetation, the flow does not appear to be impeded.

View looking upstream at the vegetation, 2019.

View looking downstream at the vegetation, 2019.

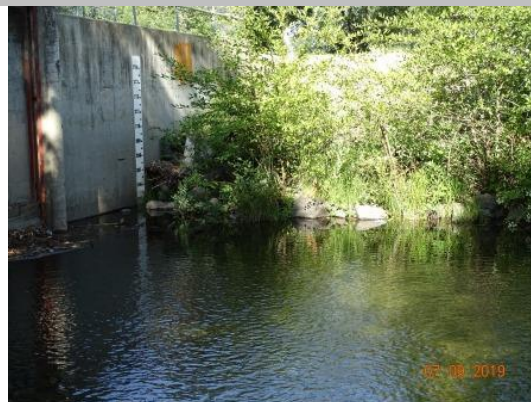
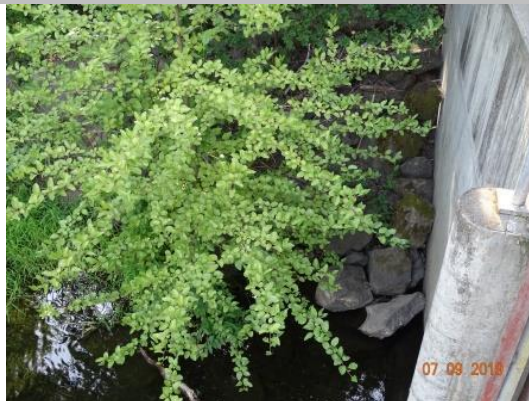
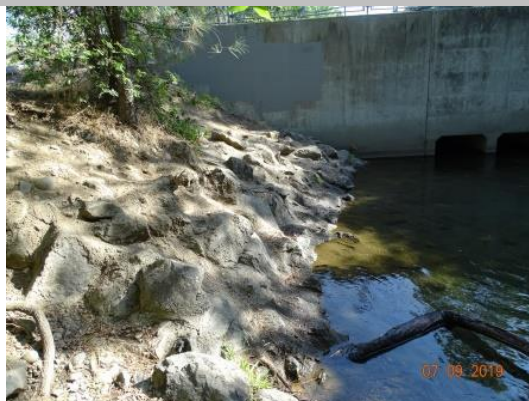
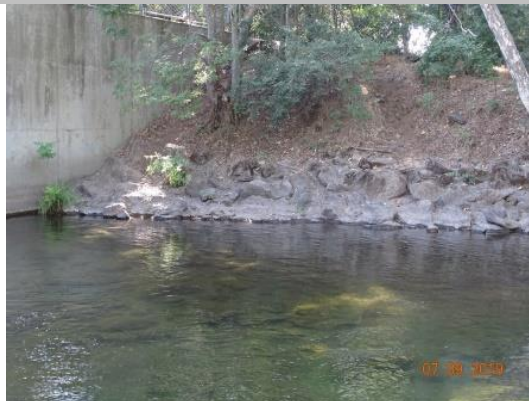
LM Start	0.00	Rating **	A	Issue No.	5
LM End	0.00	Issue Type +	Ma	Location *	
Category	Structures & Concrete Lined Channels			GPS Latitude/Longitude	
				Start	End
Item	Revetments			39.761844 °	39.761844 °
				-121.792559 °	-121.792559 °
DWR ID	DWR_NA0003_35_t_2012_5				
Action/Comments					
Inspector Comments: Riprap is visible and appears to be properly maintained, 2019.

View of revetment on the upstream side of the structure right bank, 2019.

View of revetment on the upstream side of the structure left bank, 2019.

View of revetment on the downstream side of the structure right bank, 2019.

View of revetment on the downstream side of the structure left bank, 2019.

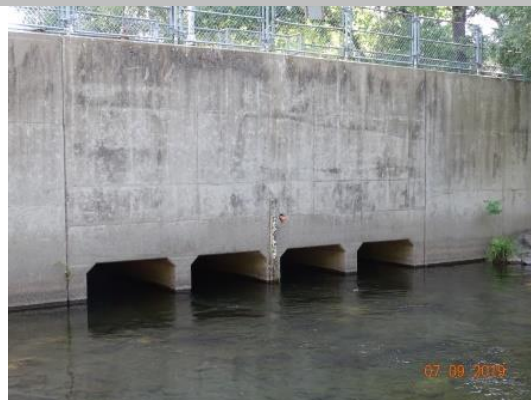
Photo 1 of 1 : ST\_2019\_NA0003\_35\_7\_20190718\_00033.jpg

LM Start	0.00	Rating **	A	Issue No.	7
LM End	0.00	Issue Type +	Ma	Location *	
Category	Structures & Concrete Lined Channels	GPS Latitude/Longitude			
		Start		End	
Item	Culverts: Inlets / Outlets	39.761844 °		39.761844 °	
		-121.792559 °		-121.792559 °	
DWR ID	DWR_NA0003_35_t_2012_7				
Action/Comments					
Inspector Comments: The culverts appear to be in good condition.

View of the outlets of the structure, both inlets and outlets are in good condition, 2019.

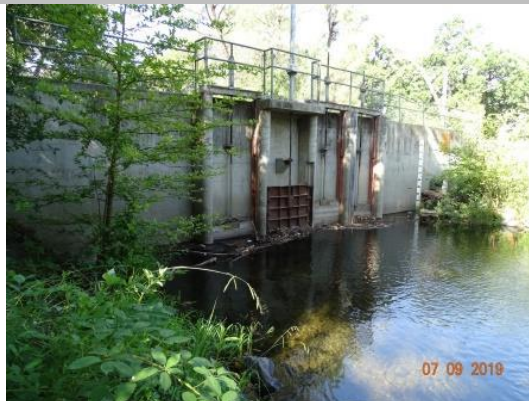
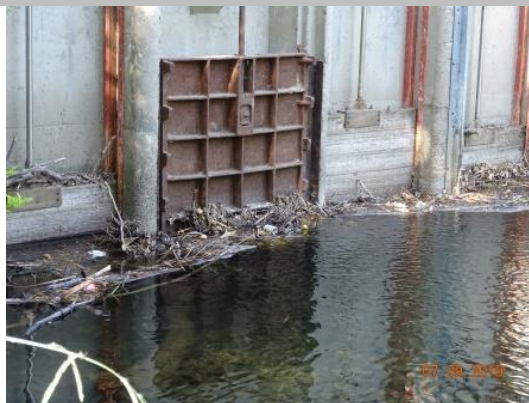
LM Start	0.00	Rating **	A	Issue No.	12
LM End	0.00	Issue Type +	Ma	Location *	
Category	Structures & Concrete Lined Channels			GPS Latitude/Longitude	
				Start	End
Item	Sluice/Slide Gates			39.761844 °	39.761844 °
				-121.792559 °	-121.792559 °
DWR ID	DWR_NA0003_35_t_2012_12				
Action/Comments					
Inspector Comments: Gate appears to be in good condition, debris in front of gates should be removed but currently is not impeding the flows, 2019.

View of slide gates, 2019.

Closer view of the slide gates. Minimal debris at gate does not appear to be obstructing flows but needs to be removed, 2019.

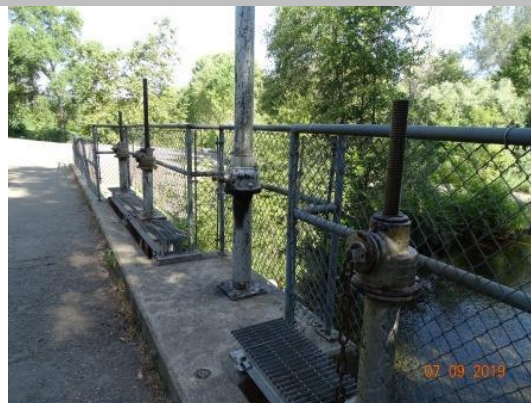
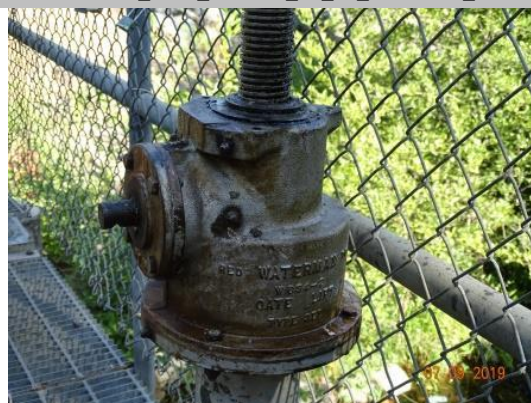
LM Start	0.00	Rating **	A	Issue No.	14
LM End	0.00	Issue Type +	Ma	Location *	
Category	Structures & Concrete Lined Channels			GPS Latitude/Longitude	
				Start	End
Item	Manual Gate Operators			39.761844 °	39.761844 °
				-121.792559 °	-121.792559 °
DWR ID	DWR_NA0003_35_t_2012_14				
Action/Comments					
Inspector Comments: Manual gate operators appear to be in good working condition. They show no damage and there is evidence of being greased and maintained. Unable to test screw gates, 2019.

View of manual gate operators, 2019.

Closer view of manual gate operator, 2019.

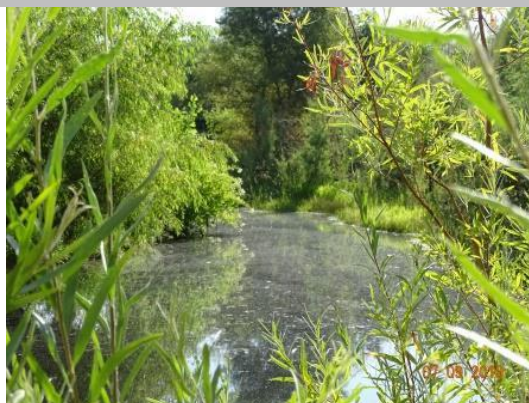
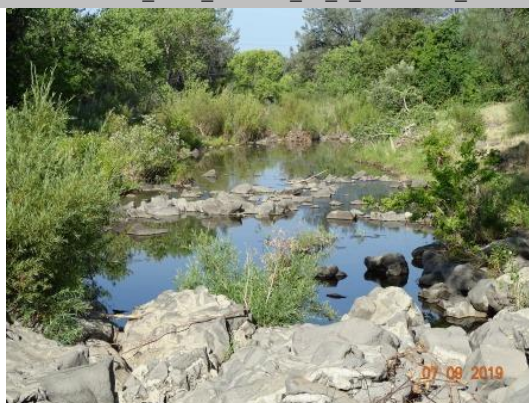
LM Start	0.00	Rating **	A	Issue No.	2
LM End	0.00	Issue Type +	Ma	Location *	
Category	Structures & Concrete Lined Channels	GPS Latitude/Longitude			
		Start		End	
Item	Vegetation & Obstructions	39.761541 °		39.761541 °	
		-121.797236 °		-121.797236 °	
DWR ID	DWR_NA0003_48_t_2012_2				
Action/Comments					
Inspector Comments: There is minimal vegetation downstream, with more grasses and some trees upstream, however the flow is not likely to be impeded, 2019.

View of the vegetation looking upstream from the structure, 2019.

View of the vegetation looking downstream from the structure, 2019.

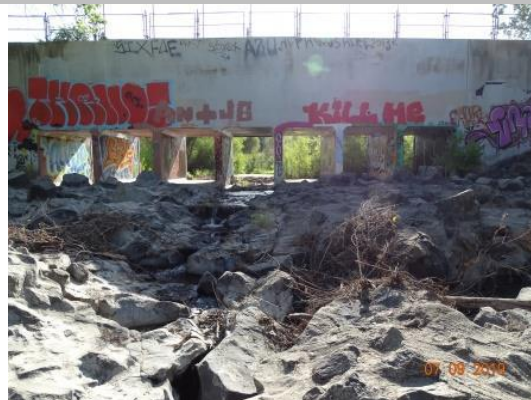
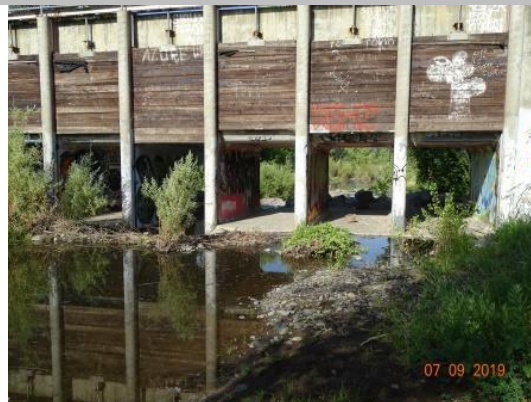
LM Start	0.00	Rating **	A	Issue No.	7
LM End	0.00	Issue Type +	Ma	Location *	
Category	Structures & Concrete Lined Channels			GPS Latitude/Longitude	
				Start	End
Item	Culverts: Inlets / Outlets			39.761541 °	39.761541 °
				-121.797236 °	-121.797236 °
DWR ID	DWR_NA0003_48_t_2012_7				
Action/Comments					
Inspector Comments: The culverts appear to be in good condition, the flow does not appear to be impeded.

View of the box culvert/outlet, 2019.

View of the box culvert/inlet, 2019.

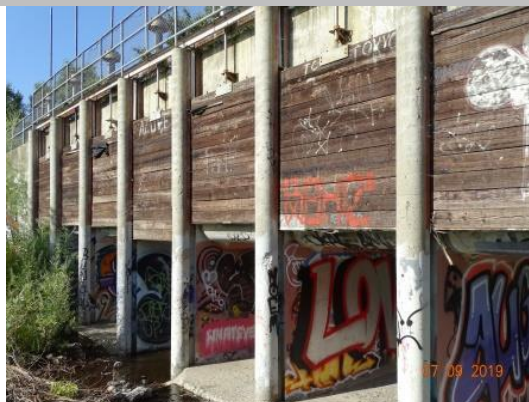
Photo 1 of 1 : ST\_2019\_NA0003\_48\_12\_20190718\_00028.jpg

LM Start	0.00	Rating **	A	Issue No.	12
LM End	0.00	Issue Type +	Ma	Location *	
Category	Structures & Concrete Lined Channels			GPS Latitude/Longitude	
				Start	End
Item	Sluice/Slide Gates			39.761541 °	39.761541 °
				-121.797236 °	-121.797236 °
DWR ID	DWR_NA0003_48_t_2012_12				
Action/Comments					
Inspector Comments: Gates appear to be in good condition, 2019.

View of slide gates, 2019.

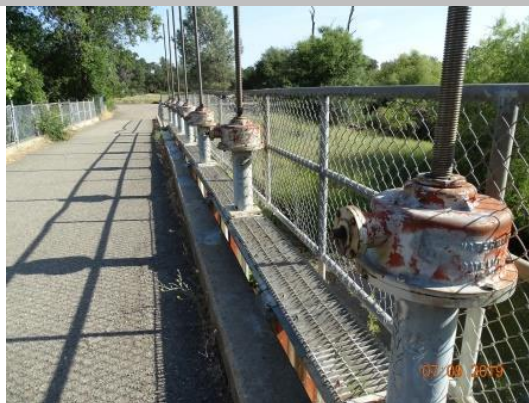
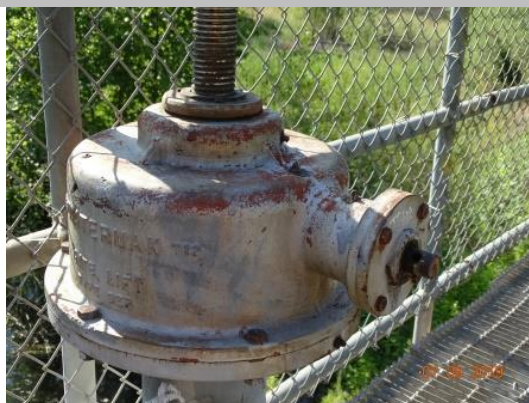
LM Start	0.00	Rating **	A	Issue No.	14
LM End	0.00	Issue Type +	Ma	Location *	
Category	Structures & Concrete Lined Channels			GPS Latitude/Longitude	
				Start	End
Item	Manual Gate Operators			39.761541 °	39.761541 °
				-121.797236 °	-121.797236 °
DWR ID	DWR_NA0003_48_t_2012_14				
Action/Comments					
Inspector Comments: Manual gate operators show no sign of damage and are greased and appear to be in good condition, 2019.

View looking north. Manual gate operators are greased and appear to be in good condition, 2019.

Closer view looking at manual gate operators that are greased and appear to be in good condition, 2019.

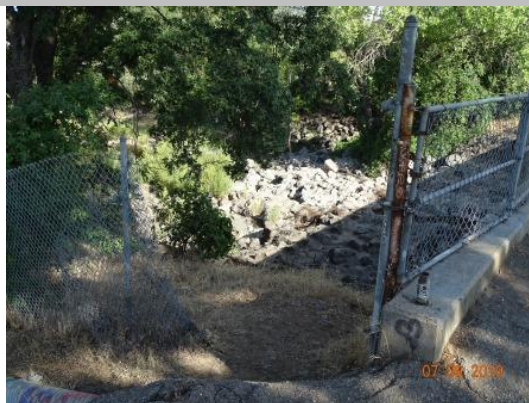
Photo 3 of 4 : ST\_2019\_NA0003\_48\_23\_20190718\_00033.jpg

View of left bank chain-link safety fence that ties to safety rail on both downstream sides have been pulled back, 2019.

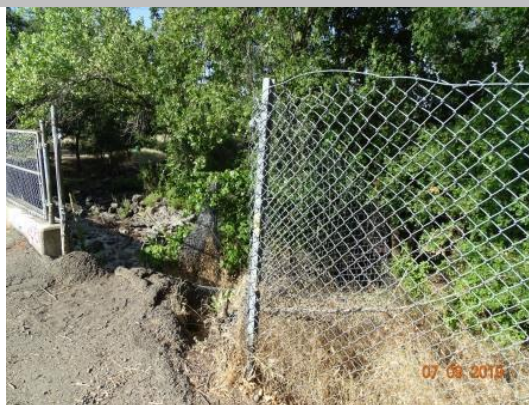
Photo 4 of 4 : ST\_2019\_NA0003\_48\_23\_20190718\_00034.jpg

LM Start	<b>0.00</b>	Rating **	M	Issue No.	<b>23 (cont)</b>
LM End	<b>0.00</b>	Issue Type +	Ma	Location *

View of right bank chain-link safety fence that ties to safety rail on both downstream sides have been pulled back, 2019.

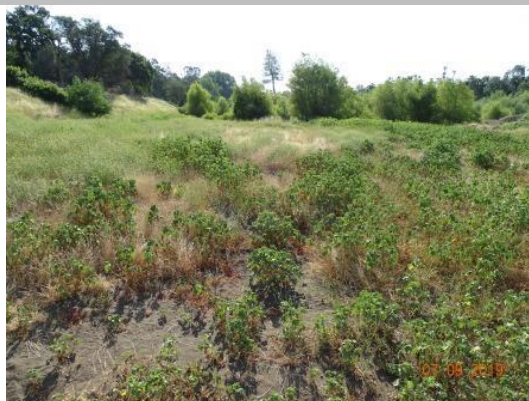
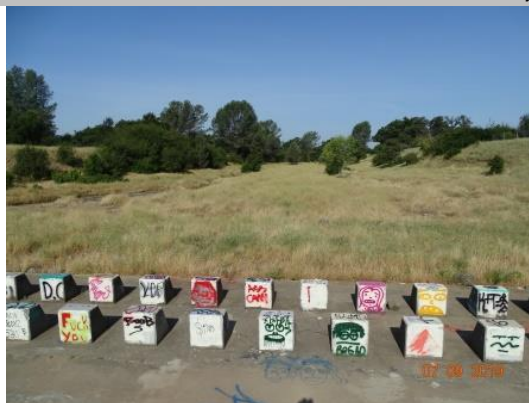
LM Start	0.00	Rating **	A	Issue No.	2
LM End	0.00	Issue Type +	Ma	Location *	
Category	Structures & Concrete Lined Channels			GPS Latitude/Longitude	
				Start	End
Item	Vegetation & Obstructions			39.762405 °	39.762405 °
				-121.797317 °	-121.797317 °
DWR ID	DWR_NA0003_8_t_2012_2				
Action/Comments					
Inspector Comments: There is vegetation however the flow does not appear to be impeded, 2019.

View of vegetation looking upstream from structure, 2019.

View of vegetation looking downstream towards structure, 2019.

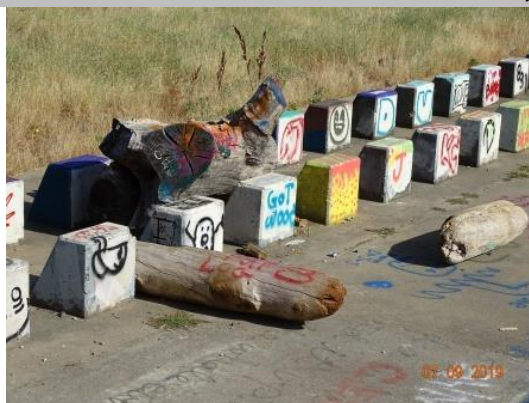
Photo 1 of 1 : ST\_2019\_NA0003\_8\_6\_20190716\_00021.jpg

LM Start	0.00	Rating **	M	Issue No.	6
LM End	0.00	Issue Type +	Ma	Location *	
Category	Structures & Concrete Lined Channels			GPS Latitude/Longitude	
				Start	End
Item	Encroachments			39.762405 °	39.762405 °
				-121.797317 °	-121.797317 °
DWR ID	DWR_NA0003_8_t_2012_6				
Action/Comments					
Inspector Comments: Stump and wood debris encroaching in weir needs to be removed, 2019.

View of wood debris caught in the weir, 2019.
